IMPACT STUDY OF THE MILLAU BRIDGE INFLUENCE ON THE LOCAL LIGHTNING OCCURENCE

Case analysis presented on the International Lightning Protection Symposium (ILPS, Portugal, April 2016)
by Stéphane PEDEBOY and Mehdi TOULLEC

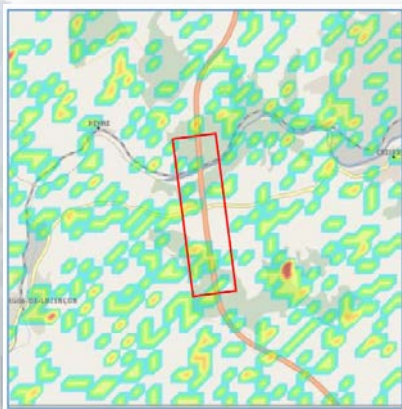
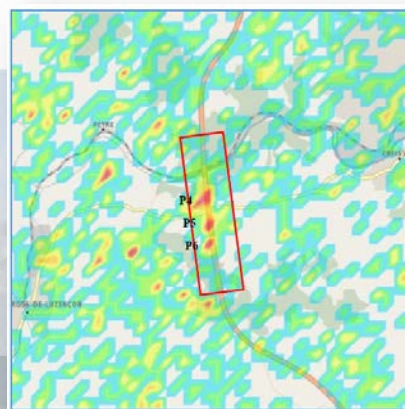
The local density before the bridge was constructed (01/1995 - 12/2001) and after the bridge was constructed (01/2005 - 12/2015)

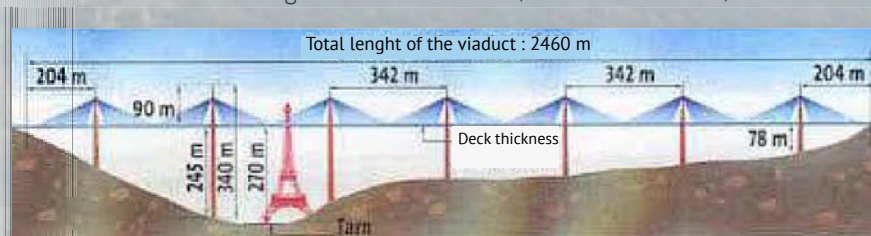
Surprisingly, not the tallest masts are related to hot lightning spots !

- several lightning strokes occurred either on the piers or on the nearby cranes during their construction.
- An interesting result showed the height of the masts is mainly involved in the enhancement of the lightning density and particularly because the masts trigger upward discharges. However, no relation was found between this enhancement and the height of the piers.
